Signalling Shared Learning Engineering Services Deliver

Issue 02 - December 2023

Introduction

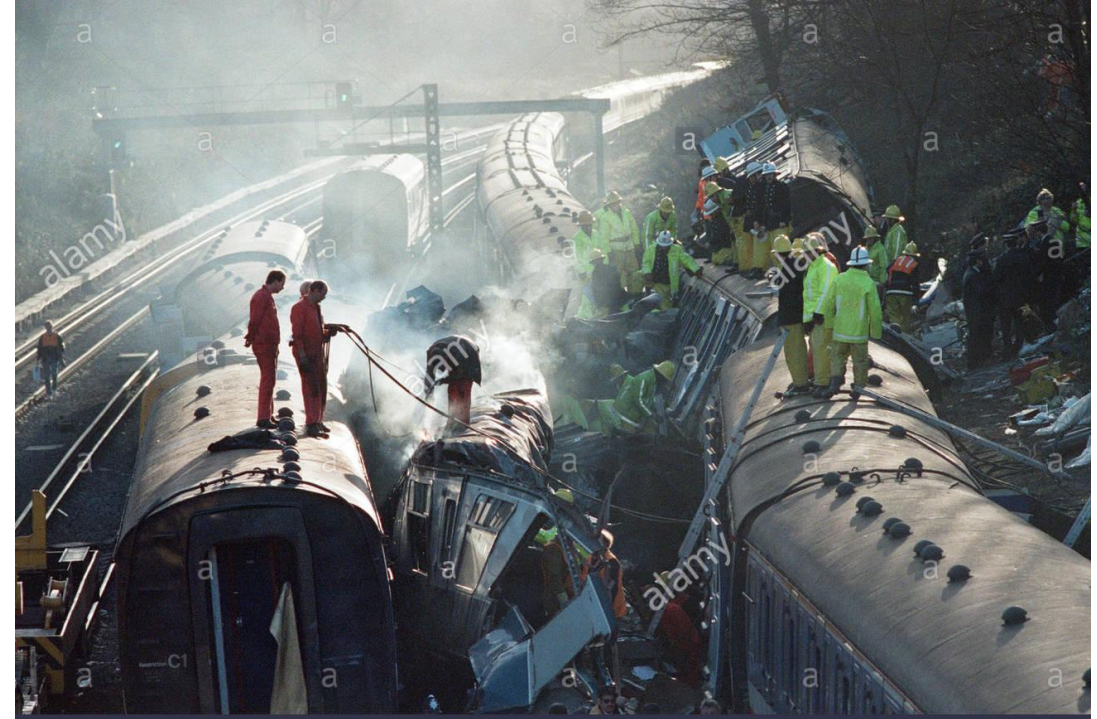
December 2023 marks the 35th anniversary of the Clapham Rail Disaster, where 35 passengers and train crew lost their lives. 484 were injured.

The disaster was caused by a single, loose and uninsulated stray wire.

This resulted in a relay energising, allowing a signal to display a green aspect when it should have been red. The result was a rear end collision between two trains, with a third train on the adjacent line colliding with the subsequent wreckage.

We must remember these historic incidents and the key learning associated with them. Many of our industry's rules, procedures, standards and practices of today are as a direct result of previous incidents and the learning from them, so a repeat can be avoided.

There is a real risk of “corporate memory loss”, of this and other accidents and the collective forgetting of what we must do, and why we do it.

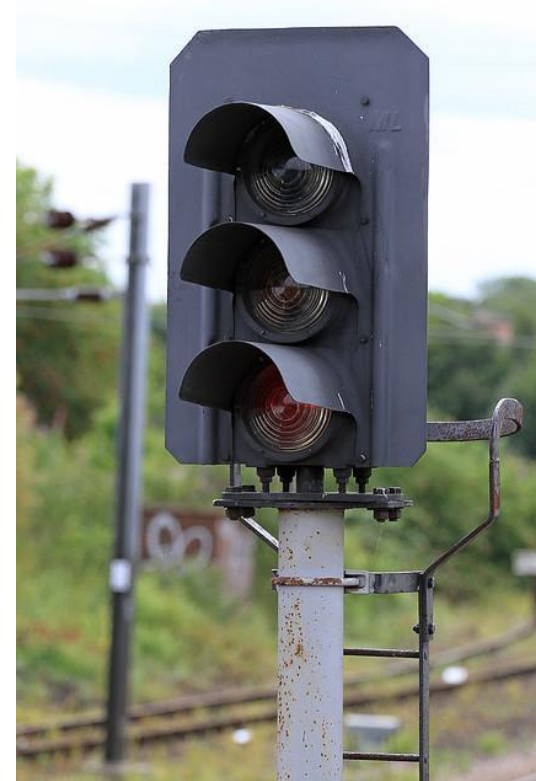
After a track renewal project, previously disconnected signal and track circuit cables were reconnected and tested using the Signal Maintenance Testing Handbook (SMTH).

One of the first trains the following morning reported receiving a red aspect following green aspects, where a yellow was expected. This train SPADed the red signal and came to a stand.

A 2nd following train then received a yellow aspect instead of the red expected, and narrowly avoided a rear end collision with the first train, only because of the actions of the train driver and the signaller.

This incident is one of several SMTH irregularities recently experienced. All staff, particularly SMTH testers, are reminded of the importance of carrying out SMTH fully and correctly, and of the independence required between installation and test.

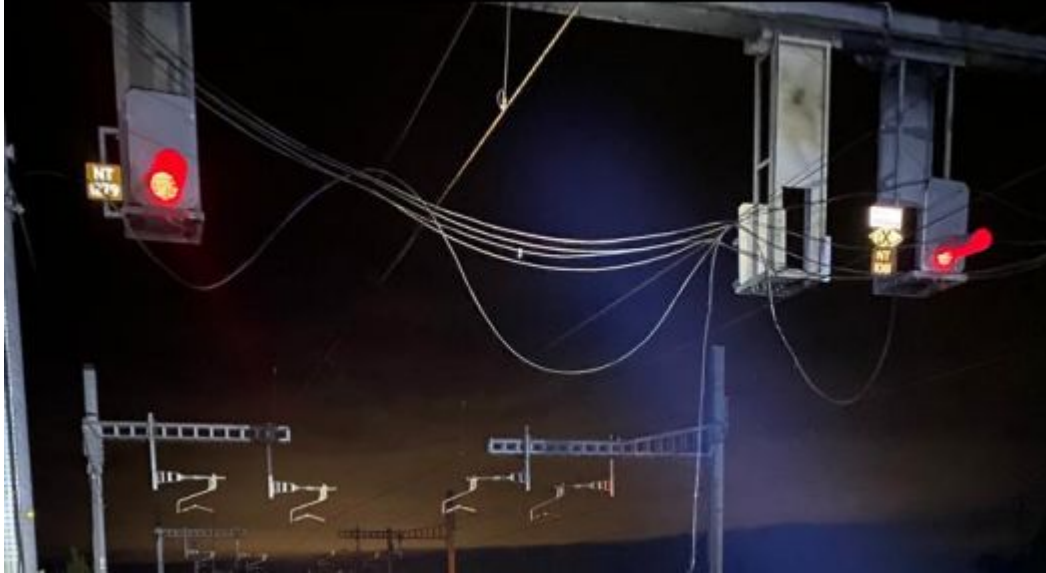
Cable ties on gantry

Multiple signal cables fell from a signal gantry onto the OHLE below, causing considerable damage to a signalling location case. The cable tray was mounted vertically, conflicting with current standards, but allowed at time of installation.

NR/SP/SIG/19812 Cross Track Cable Management and NR/BS/LI/424 state:

- “New cabling shall not be attached to...
d) a cable tray or containment system using cable ties or fixings that are susceptible to degradation from heat, moisture and ultraviolet radiation within the design life of the system.”

Projects are reminded they are to install cables on gantries and other structures in line with this guidance, using an approved method of securement.

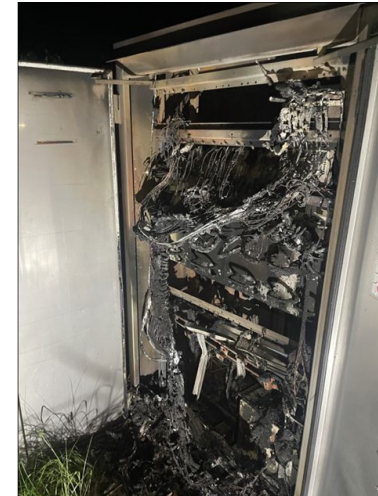
Insecure cable on gantry

After a period of strong winds, a cable that had been secured to a signal gantry became loose, and arced from the 25kV OHLE causing extensive damage to the signalling apparatus. The equipment had been installed around 5 years previously.

Investigations highlighted standard nylon cables ties had been used to secure the cables to the gantry structure, contrary to NR/SP/SIG/19812 Cross Track Cable Management and NR/BS/LI/424 which states:

This is believed to have caused the cables to come free.

Projects should ensure they install cable on gantries and other structures in line with this guidance, using an approved method of securing.

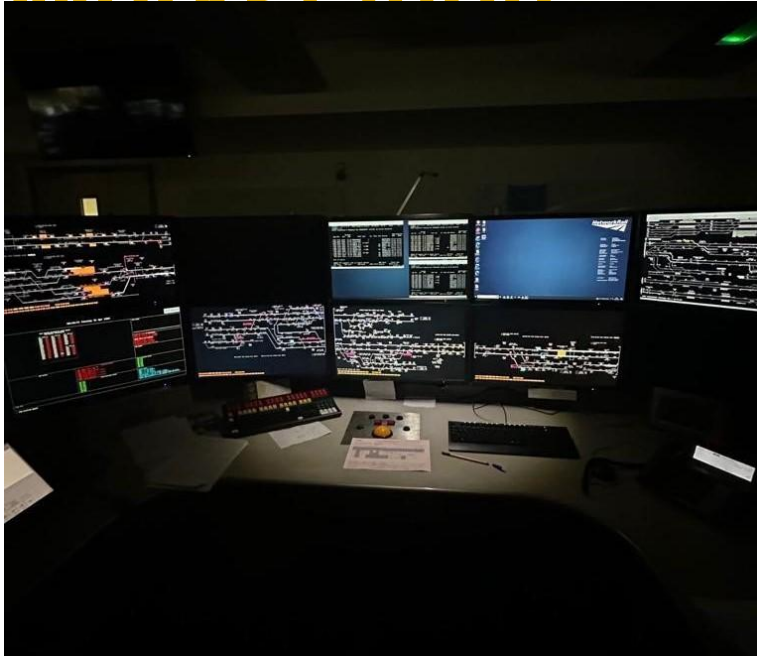
Signaller Reminder on ARS Workstation

An existing SSI interlocking had been altered several times over the previous ten years, as part of various signalling interventions and re-controls. During this period, some non-safety critical functions were implemented in the Control System environment, rather than the interlocking.

The signaller at a ROC workstation reported an occurrence that with Signaller reminder applied on a particular signal, the Automatic Route Setting (ARS) system 'signalled' a train through the signal to the next section.

This signal had been altered as part of previous works to enable ARS.

Data to perform Signaller Reminder applied check on ARS requested routes had been omitted from the system wide application for signals in the interlocking area.

No check of the Signaller Reminder Applied function was performed by the signalling and control system when ARS made the route request.

Close attention should be paid to legacy systems where controls may not be as expected, and where assumptions may cause issues that are not immediately visible.

Over recent years there has been an increase in controls deemed non-safety critical being moved from the interlocking to the control system. As the controls can reside in either system it is important that the location and responsibility is identified, understood and documented. If required, clarification is to be sought from the Infrastructure Manager.

Formalise all decision making, especially where transferring responsibility and seek confirmation of actions being allocated, actioned and closed.

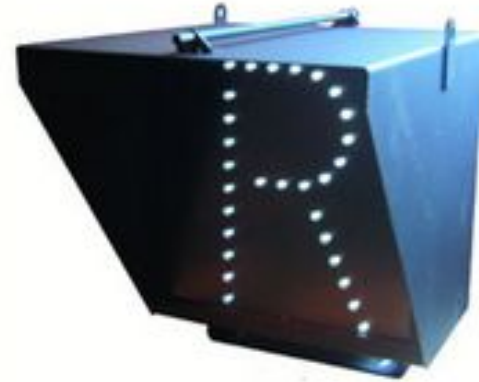
LED Route Indicators- Terminal Allocation

There is no standard convention for the assignment of indication circuit wires to the terminal block in the Miniature and Standard LED Indicator enclosure. Terminals are assigned in the location design; but this may not be issued to the supplier.

A signal was provided with a SARI which initially had four route indications and the design was issued for factory construction. Subsequently, a design modification was issued to modify a Platform 2 route indication to “2D” and “2U”; as the same destination can be approached via two different routes. The route indication arrangements were communicated to the supplier; however, the issued design required to be modified on site to match the route indicator internal wiring.

Projects and designers are asked to adopt the convention that terminals are numbered in the indications in alphanumerical order, i.e.

- Alphabetical (A to Z); then,
- Numerical (0 to 9); then,
- Alphanumerical (A1 to Z9)
- Numeric-alphabetical (1A to 9Z)

Projects must be aware of this hazard and ensure that indications correlate to the wiring at the pre-testing stage, by illuminating the aspects at a suitable and safe time.
